Ordinary Construction Case Study

Floor Renovation – Concrete Floor Over Wood Joists

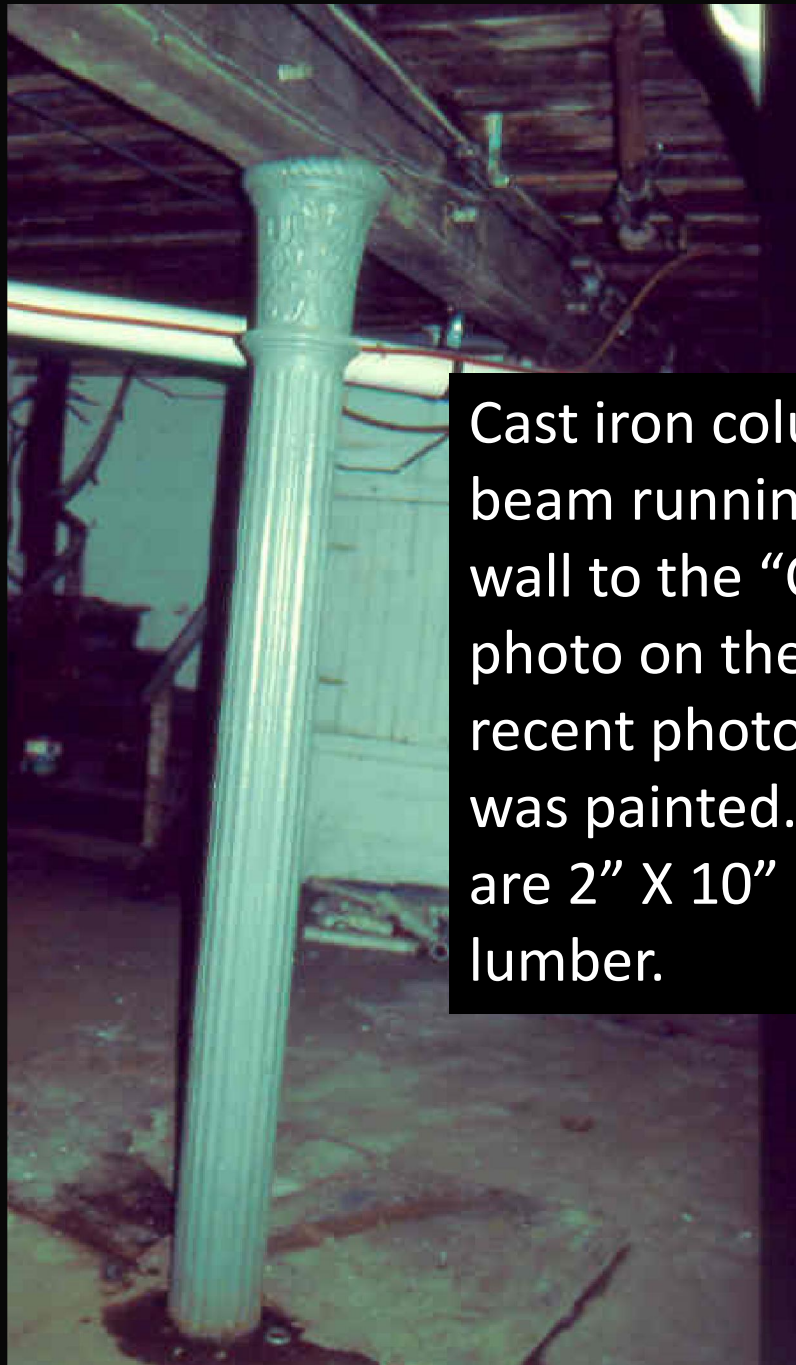
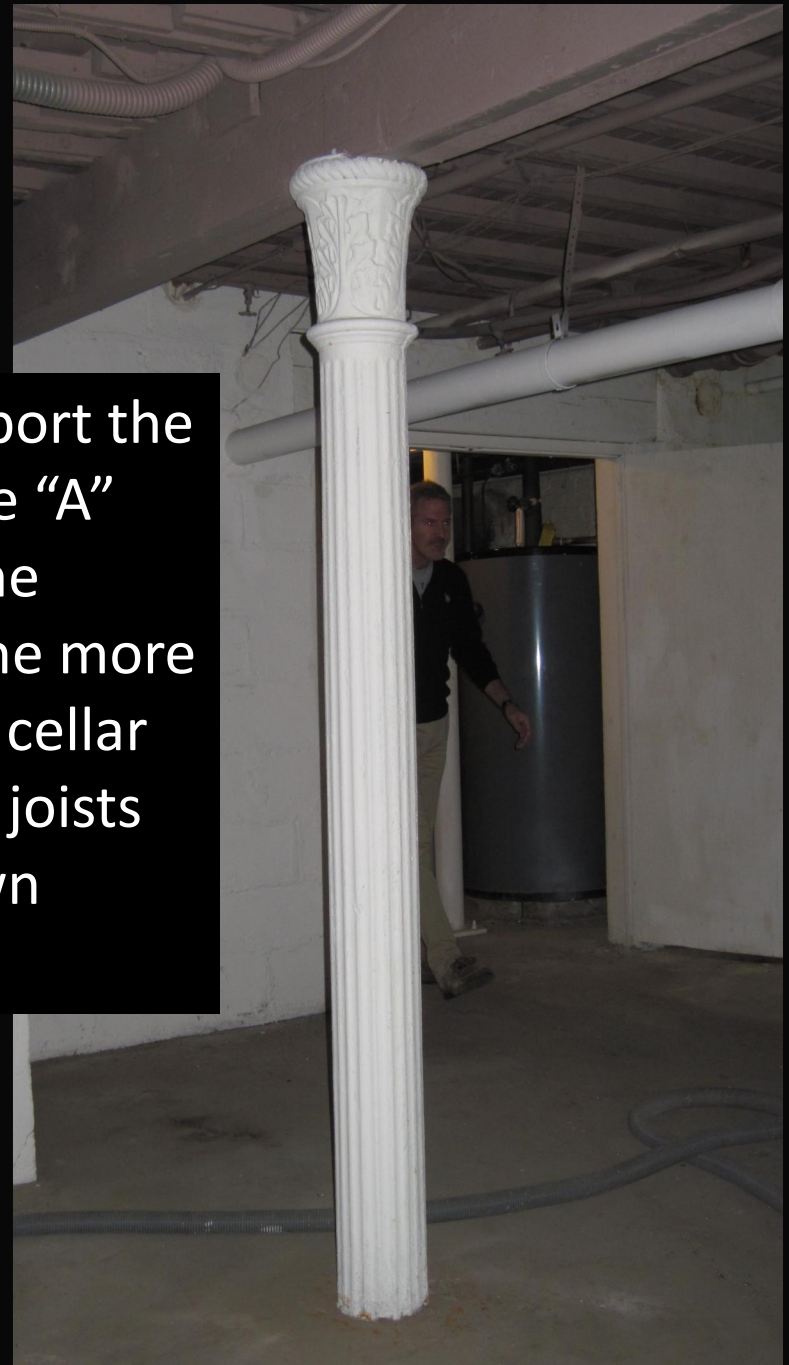
Cast iron columns support the beam running from the "A" wall to the "C" wall. The photo on the right is the more recent photo after the cellar was painted. The floor joists are 2" X 10" rough sawn lumber.

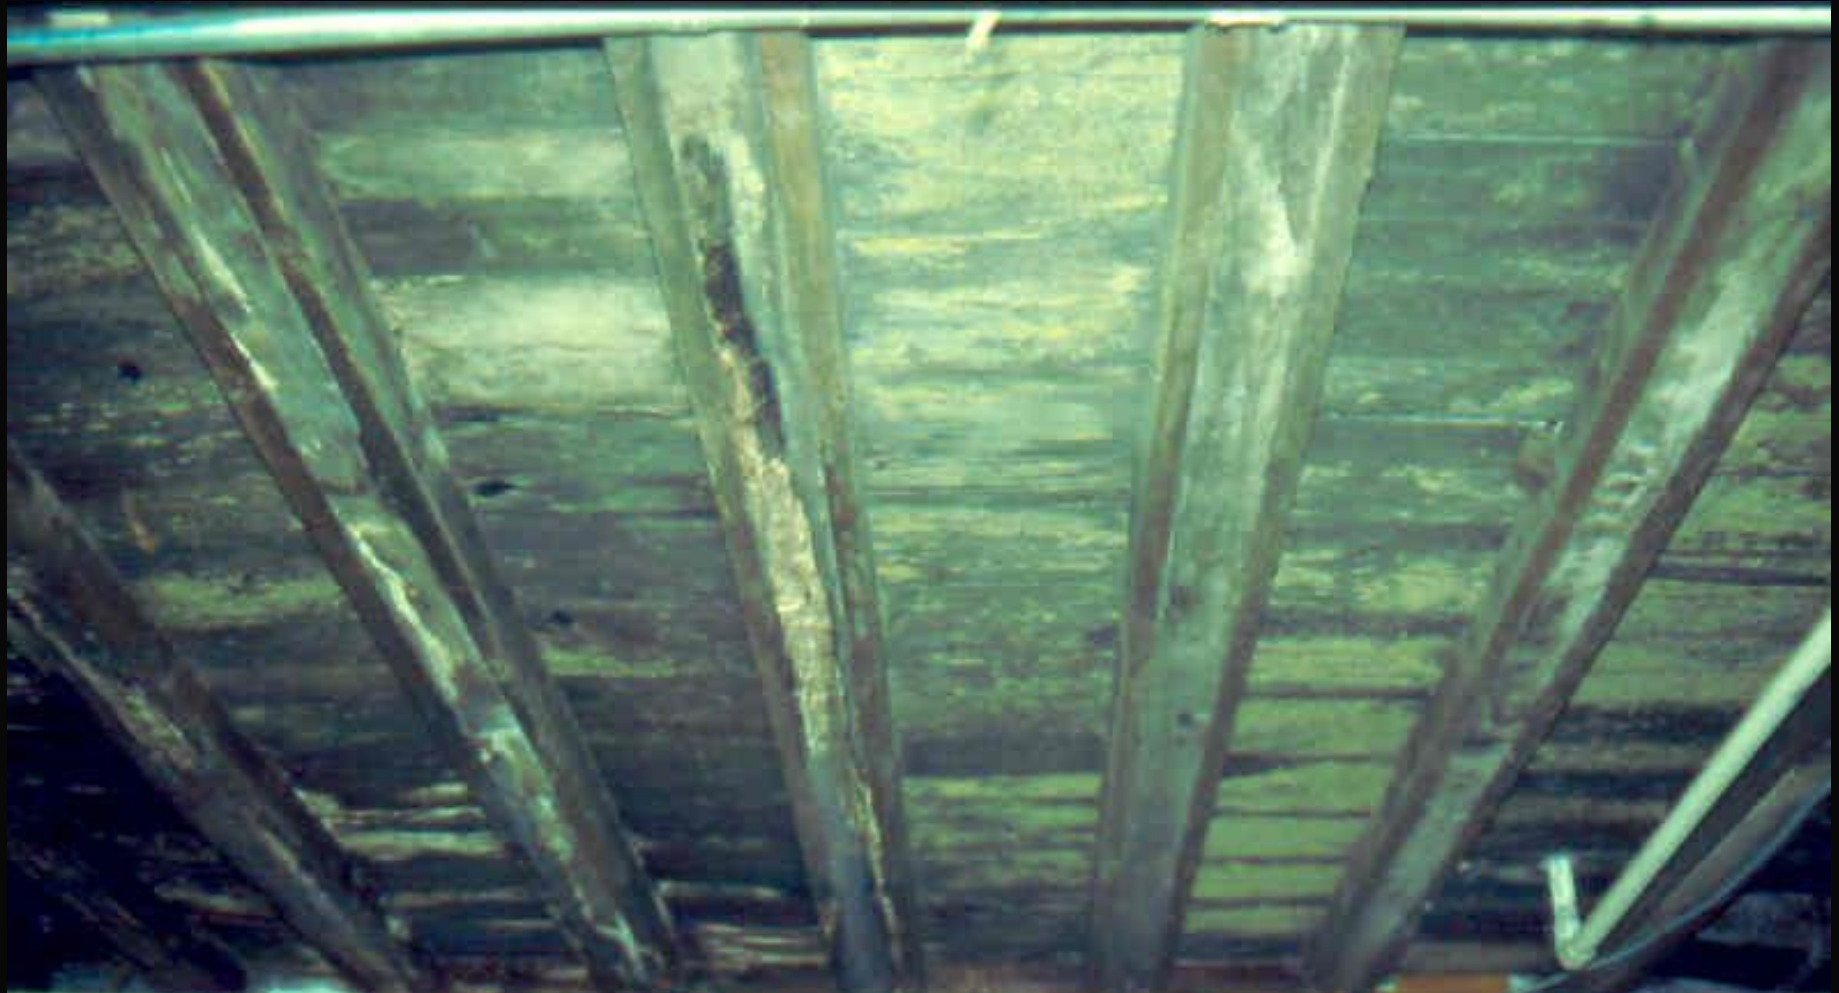
This photo depicts the condition of the first floor at the rear 1/2 to 1/3 of the floor area. Notice the floor joist are not visible to the full vertical dimension of the floor joists. There is also evidence of water damage to the floor joists and sub-flooring.

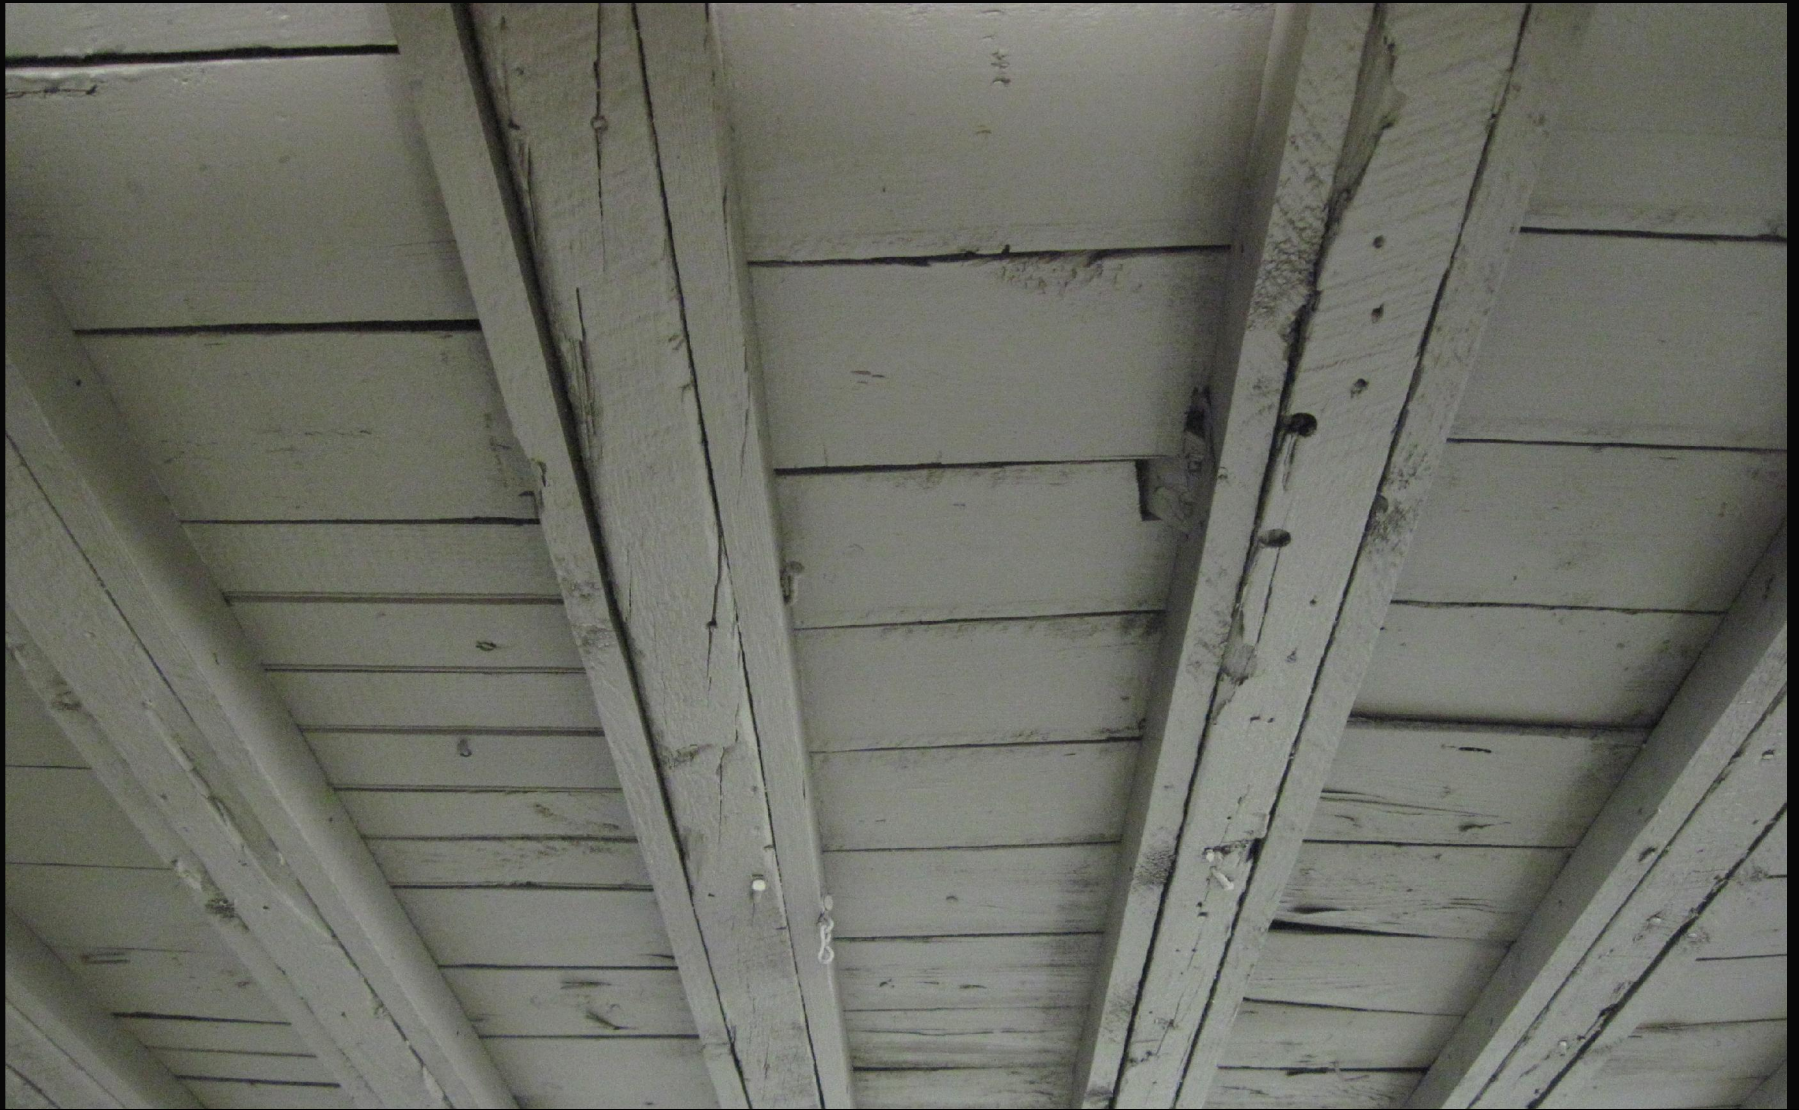
This is a later photo of the first floor at the rear 1/2 to 1/3 of the floor area. Notice furring strips nailed to the sides of each floor joist near the bottom of each joist.

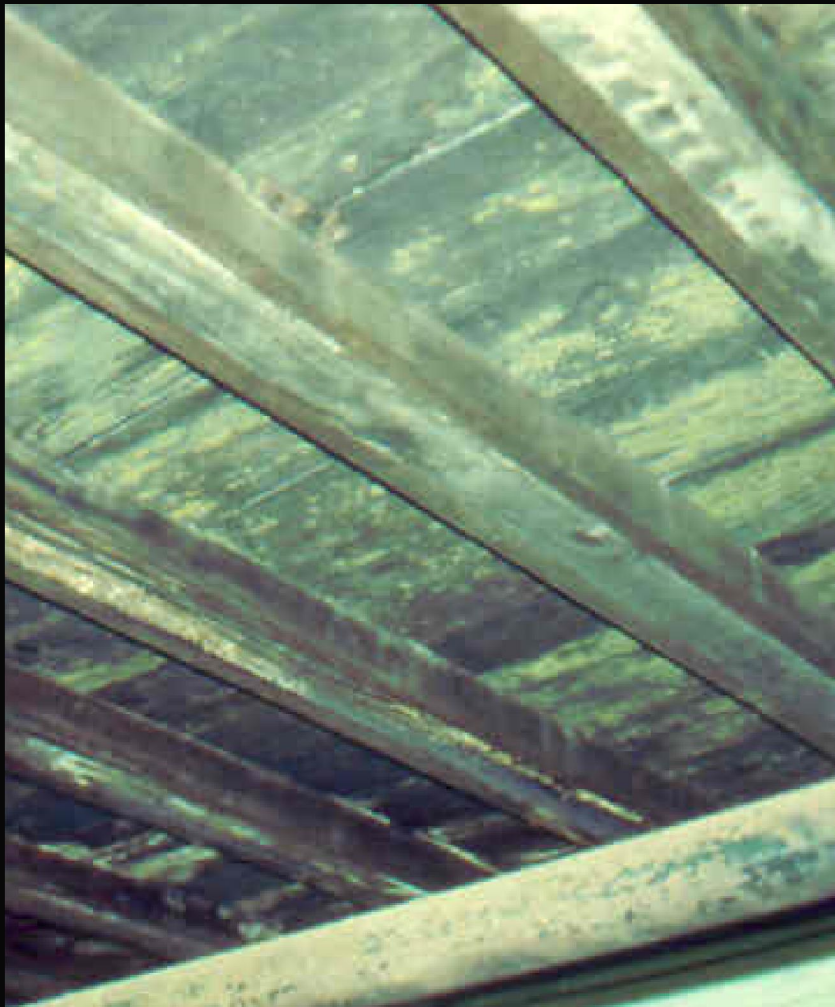
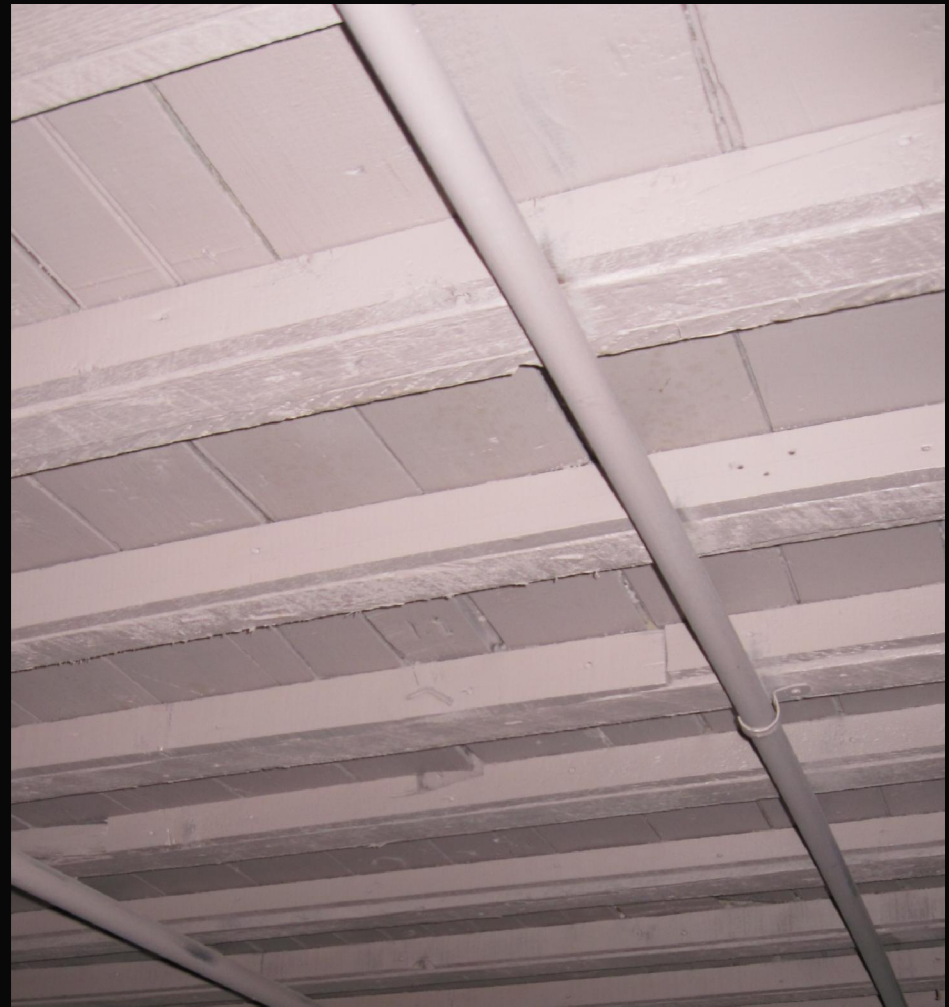
The photo on the right is the later photo, take note of the subflooring material, the subflooring material was removed from the original floor, cut into 14" to 14.5" lengths and placed on top of the furring strips between each floor joist.

A concrete floor was poured over the altered wood floor filling the spaces between each floor joist with concrete.

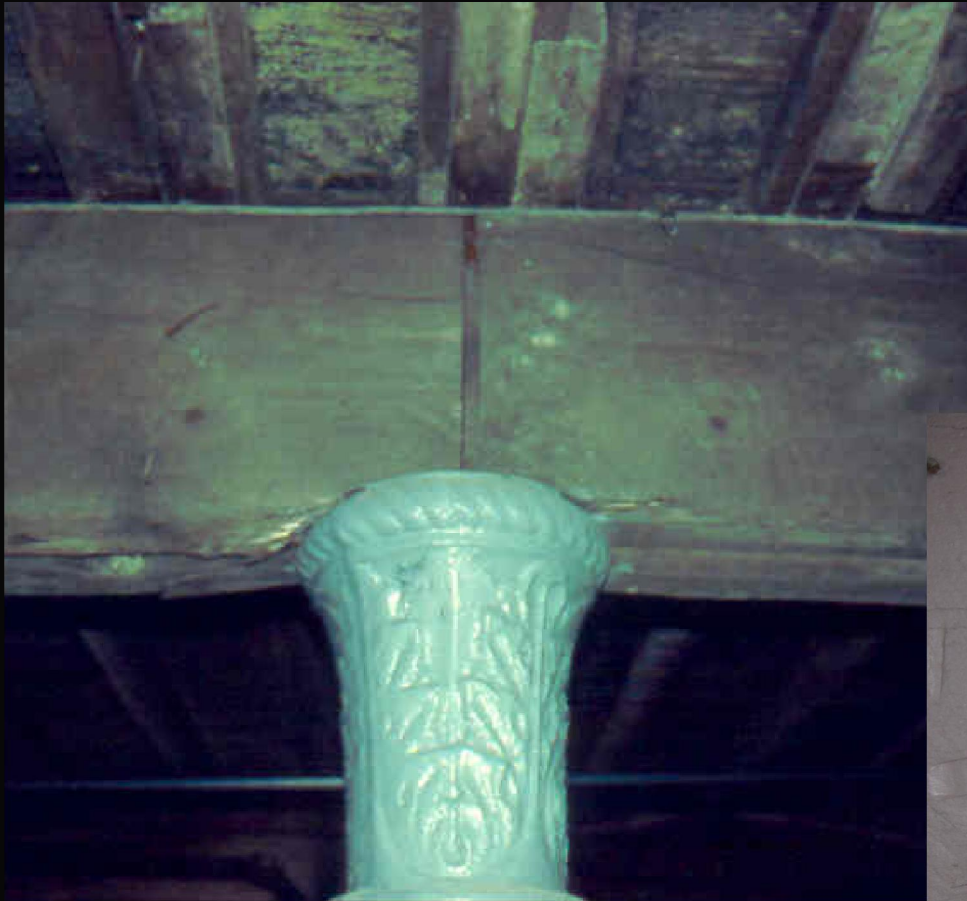
The added dead load of the concrete floor has caused the wood beam to crush down over the tops of the cast iron columns.

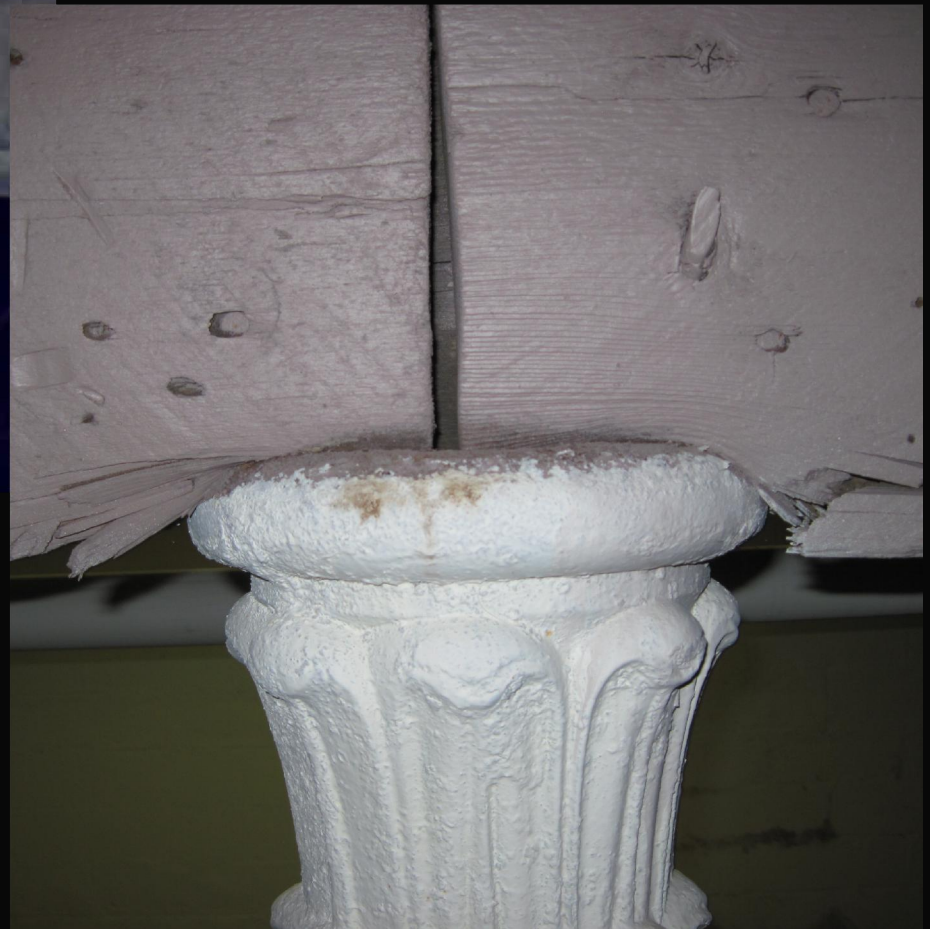
Another photo of the wood beam crushing down over the tops of one of the cast iron columns. Deterioration of the wood likely from water damage is also visible in this photograph.

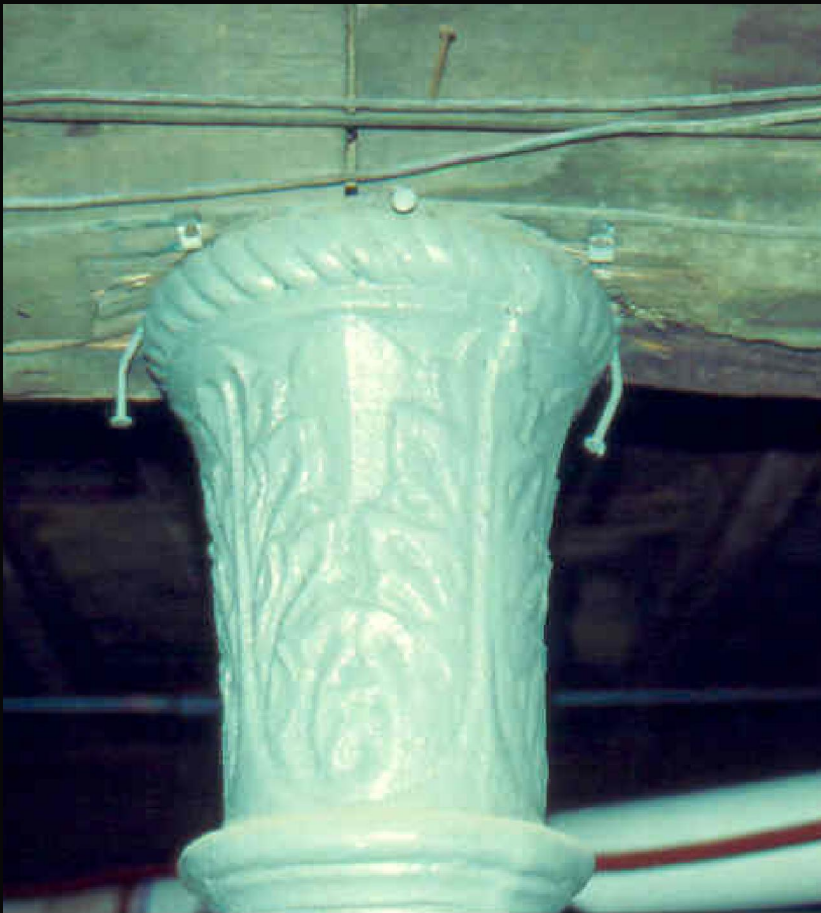
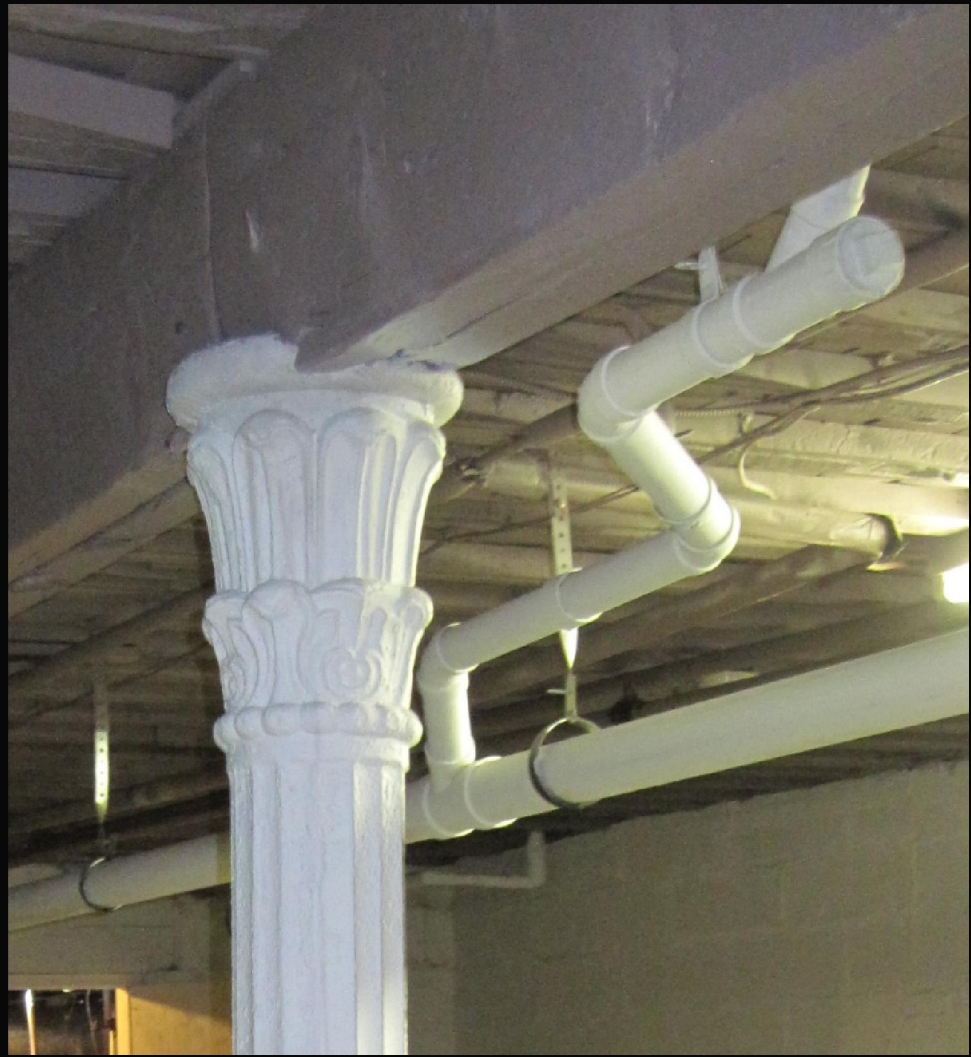
Additional photos of the wood beam crushing down over the tops of the cast iron columns. This condition existed at several column/beam connection through out the cellar.

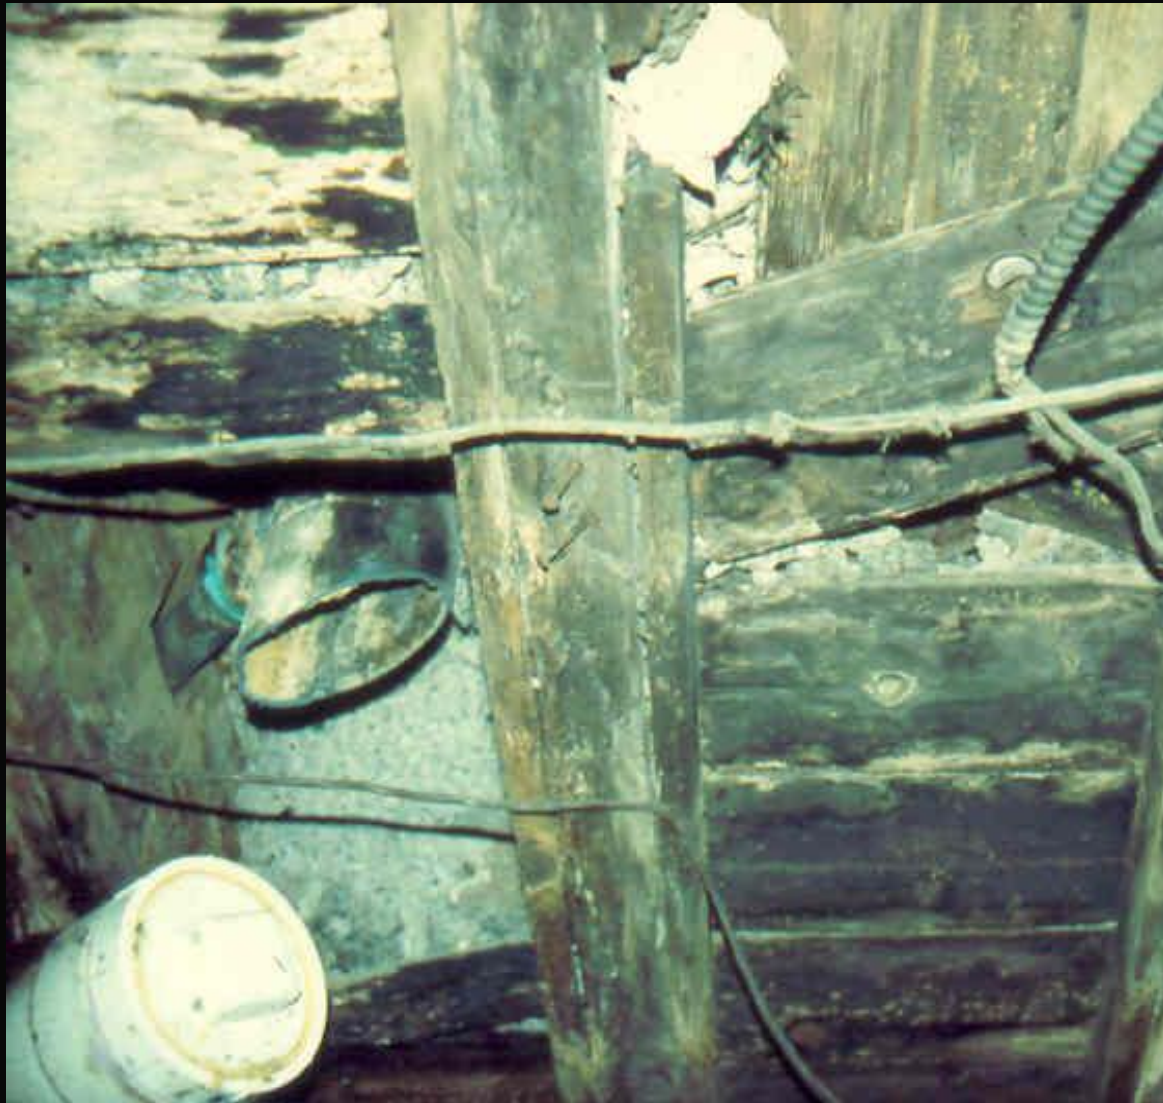
The concrete poured over the wood joist floor is obvious in this photo where the plumbing DWV pipe passed through the floor.

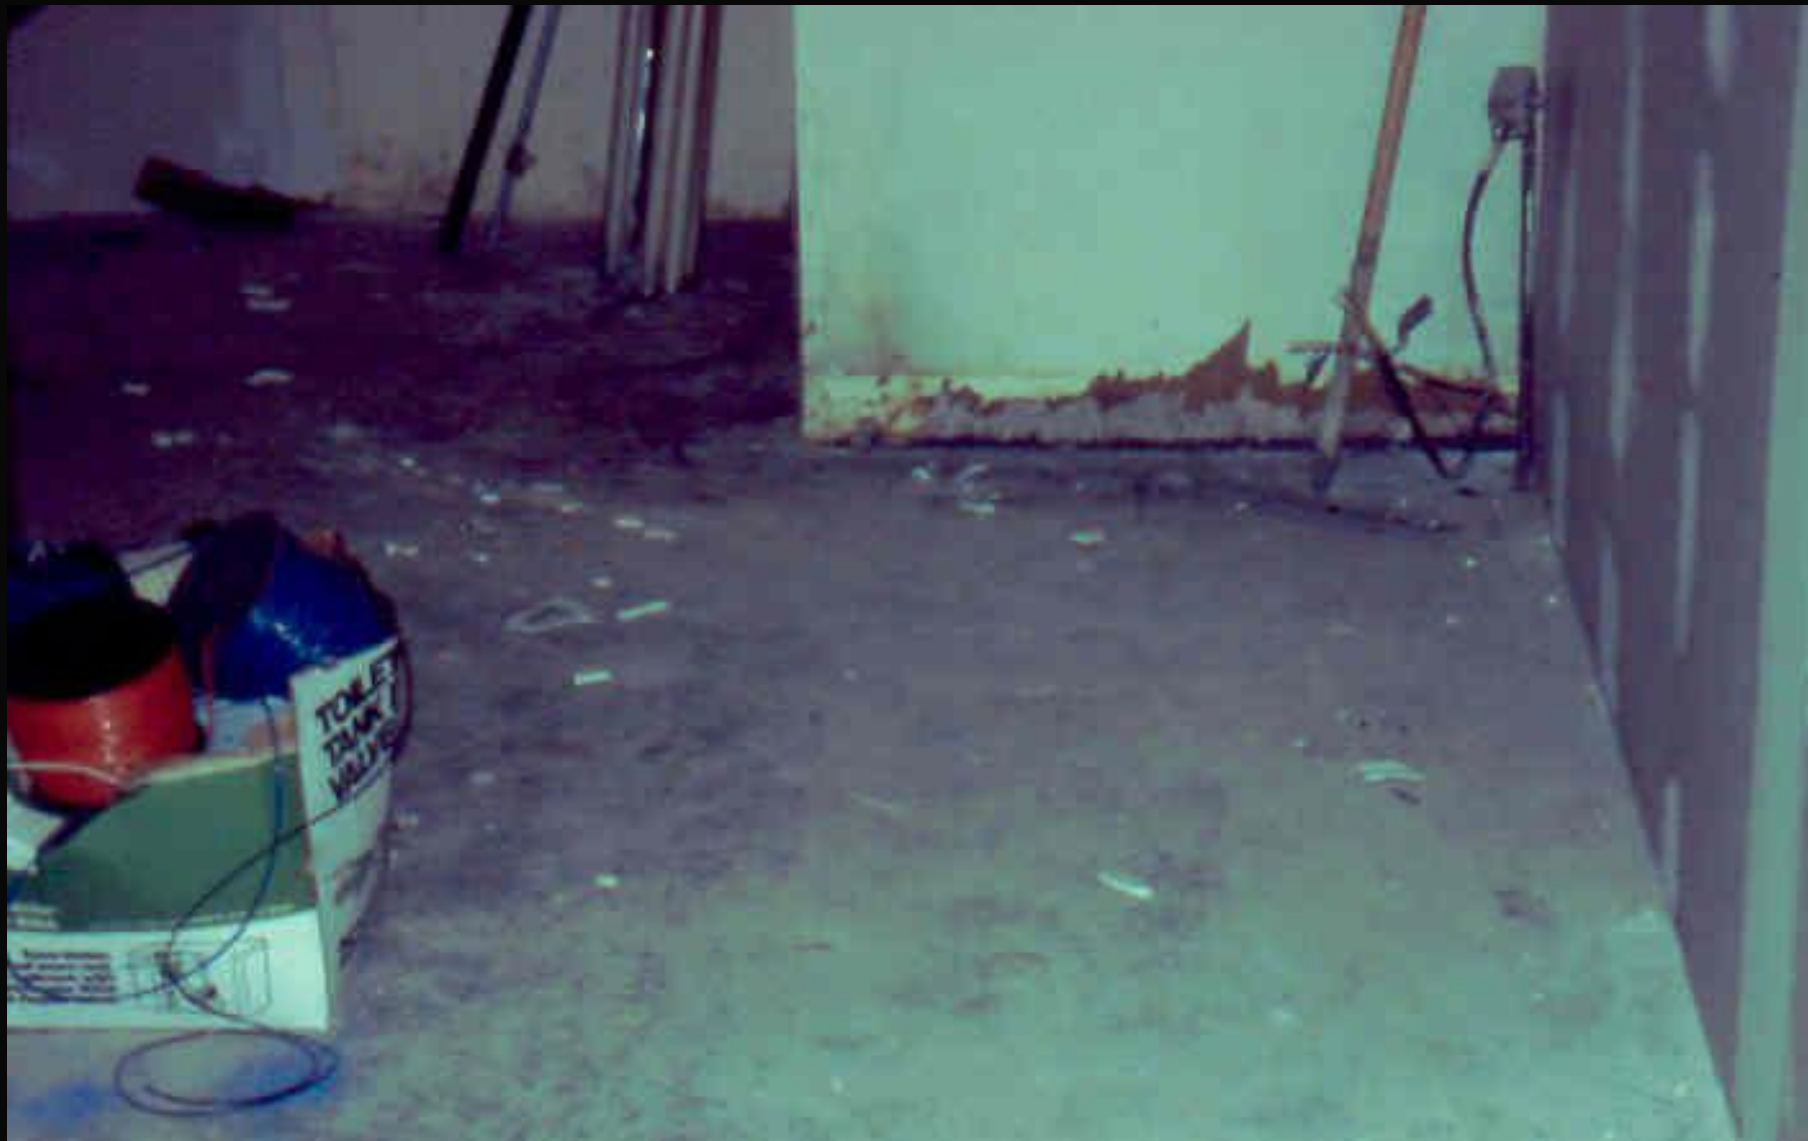
This photo depicts the finished floor looking at the top of the concrete slab poured over the wood floor joists.

The alteration that added the concrete floor over the wood joists was accomplished by removing the finished and sub flooring from the area of the first floor. Wood furring strips were attached at or near the bottoms of each floor joist. The original subfloor was cut to fit between the floor joist bearing on the furring strips. The concrete was poured over the floor. This alteration added significant dead load to the structure.

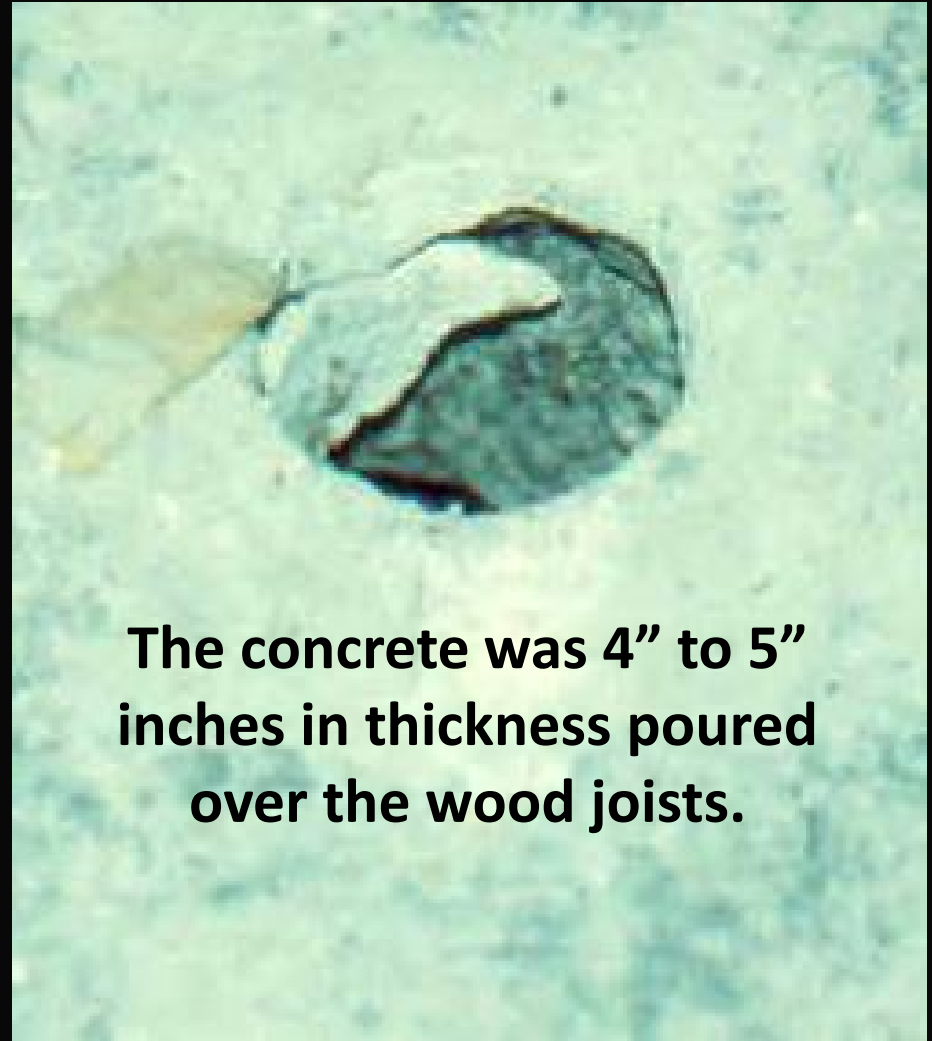
The concrete was 4" to 5" inches in thickness poured over the wood joists.
