FIRE PREVENTION ACADEMY

HISTORIC FIRES SERIES

LOCATION: Rhythm Night Club, Natchez, MS

CAUSE: Accidental/Flammable Finishes

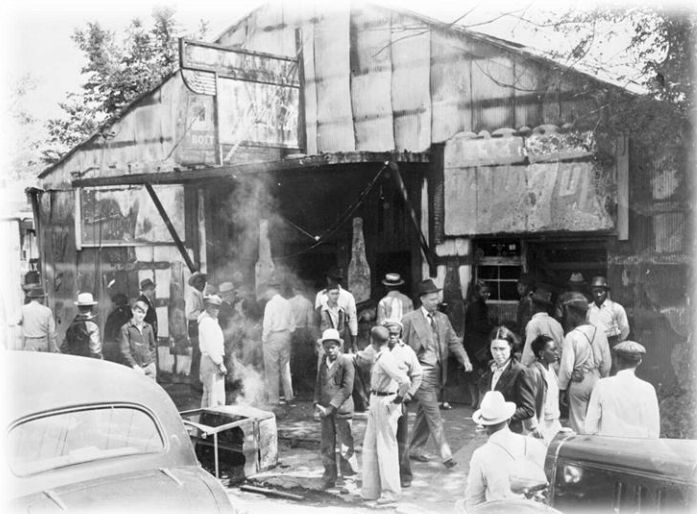
The exterior of the club.

The club was a single-story, wood building with corrugated steel siding, 120 ft X 38 ft with 24 windows that were mostly shuttered or nailed shut at the time of the fire. There was only one exit, with an *inward opening door*, that opened into a main entrance foyer that had another set of doors *that also opened inward*. On the night of the fire, the club recorded 577 paid admissions and 150 passes. The orchestra had 14 members and 5 attendants, bringing a likely final total number of people at the club to 746. Advance tickets for admission cost \$0.50, tickets at the door cost \$0.65, and the average age of attendees was between 15 and 25 years old. The fire started near the main entrance door around 11:00 P.M. fed by Spanish moss that had been draped over interior rafters as a decoration, which quickly engulfed the structure. To ensure there were no bugs in the decorative moss, it had been sprayed with FLIT, a petroleum-based insecticide. Under the dry conditions, flammable methane gas was generated from the moss.

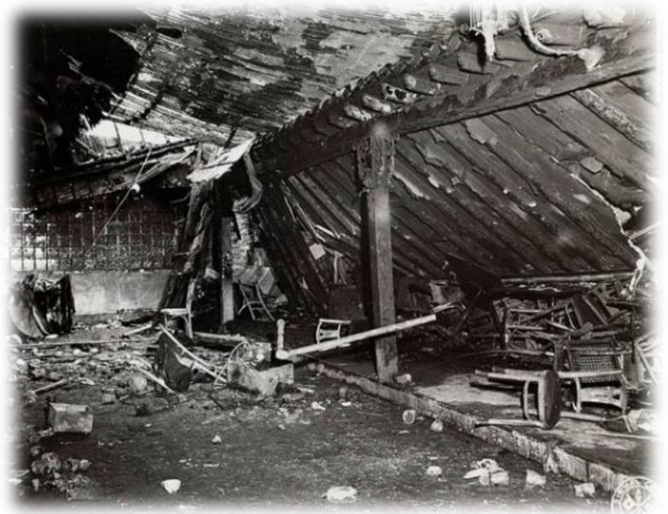
What's left of the interior.

Twenty one of the 24 existing windows had been boarded up to prevent outsiders from viewing or listening to the music, and as a result the crowd was trapped. Some survivors were able to get out through the front door or through the ticket booth, while others tried to press their way to the back door, which was padlocked and boarded shut. Upon realizing their limited options to escape the fire, many victims attempted to break through the corrugated steel walls of the building but were unsuccessful. People broke through windows using their hands and chairs, but the windows became jammed. Blinding smoke made movement difficult. Survivors remembered the burning moss falling from the ceiling and forming a barrier between the dance floor and the exit, with the moss igniting clothing and hair of victims and survivors. The front door was the only exit, and the doors swung inward. Escape from the main entrance was made almost impossible as flames blocked the entrance, pushing the crowd towards the back of the club. Due to the walls being made of metal, and little ventilation for the heat or smoke, the walls held the heat in the club like an oven. When water from the fire hoses hit the metal siding, it created steam that scalded many victims. Doctors later found that most of the dead had

succumbed to the smoke or were crushed as the crowd was pushed to the rear of the building. Most of the bodies were found piled near the rear of the building by the bandstand with the stacked bodies reaching shoulder height.

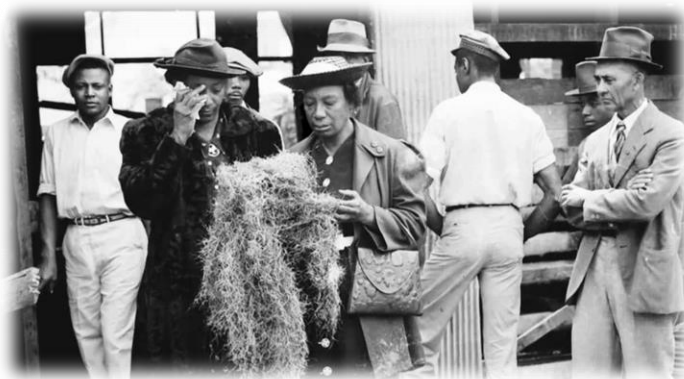
A local woman holds a batch of Spanish moss the day after the fire that ironically, didn't burn up during the fire the night before.
