Ordinary Construction Case Study

Floor Renovation – Concrete Floor Over Wood Joists

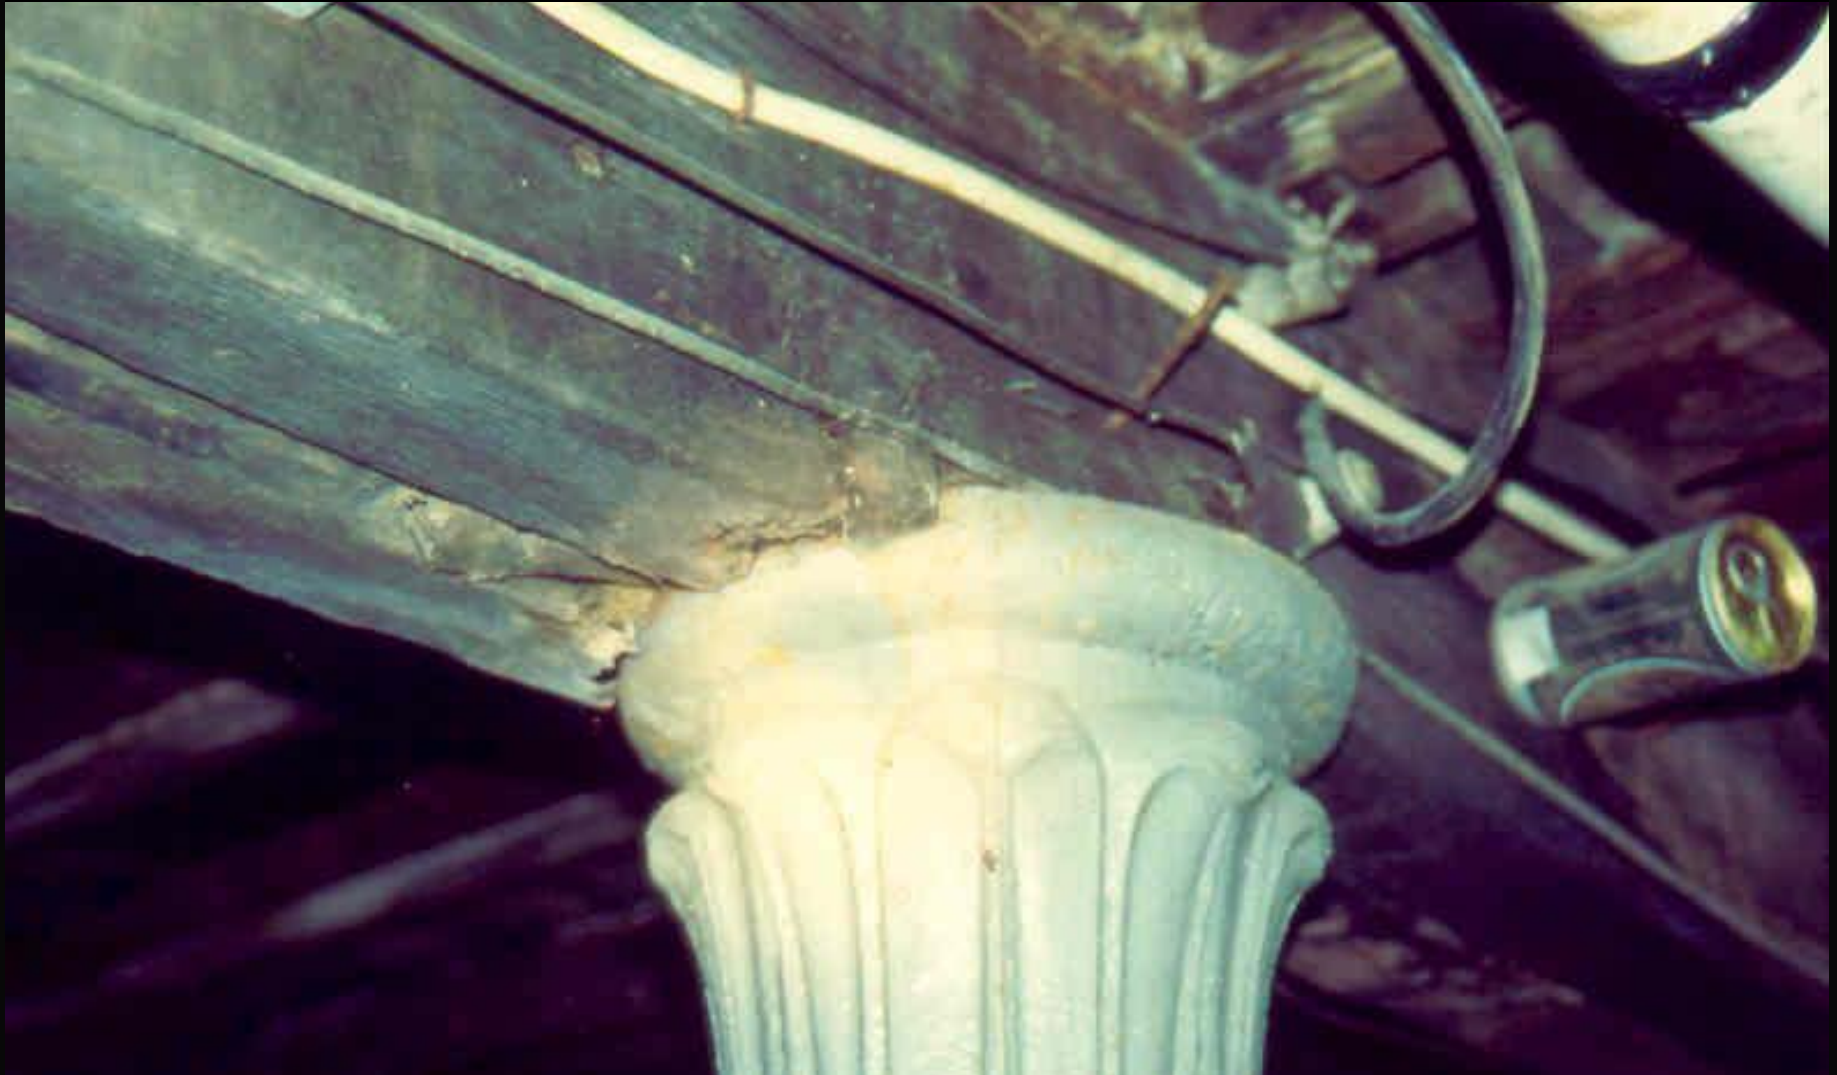
Another photo of the wood beam crushing down over the tops of one of the cast iron columns. Deterioration of the wood likely from water damage is also visible in this photograph.

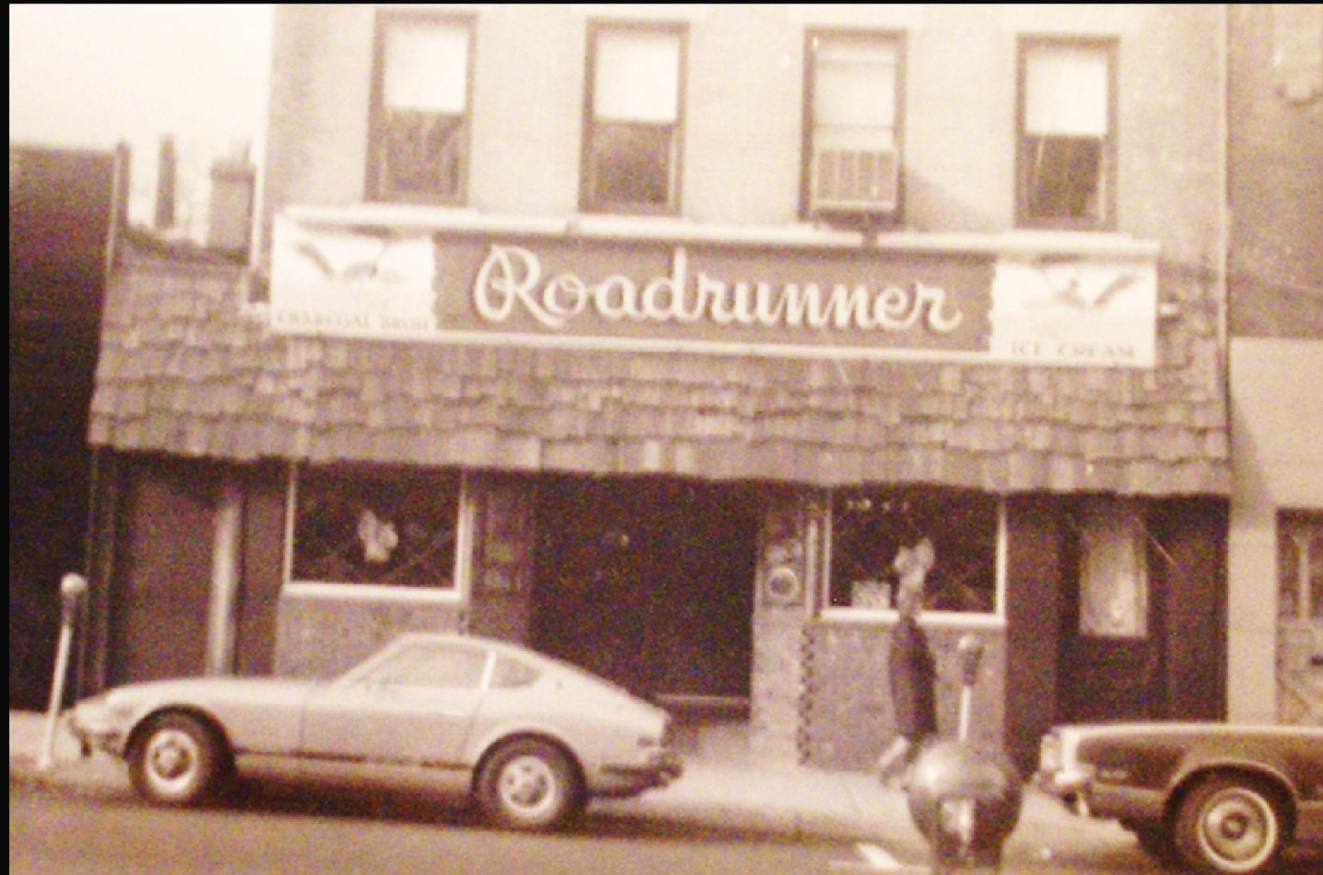
It is believed the alteration to the floor system may have been accomplished when the building was renovated for occupancy as a restaurant which is depicted in the old photo below. Firefighters and fire officers should be aware of alterations such as depicted in these slides, this alteration greatly impacts the structural integrity of the building when being attacked by fire and creates both strategic and tactical challenges.
